## Lab Report XRF 443

# Analysis of a Roman sword with the M4 TORNADO

This report describes the analysis of parts of a Roman sword. After removing the corrosion layers, the sword was analyzed with Bruker's  $\mu$ -XRF spectrometer M4 TORNADO.

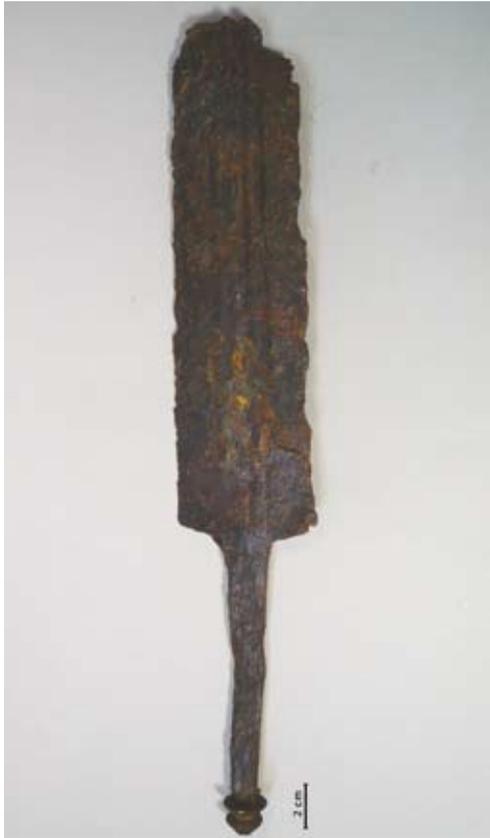
Fig. 1 Image of the Roman sword showing the remaining corrosion patina after cleaning.

The examined object is a Roman sword of a type called Gladius (see Fig. 1). It was found in the north-east of Germany, close to the town of Pasewalk. Several manufacturing features indicate that the sword was not manufactured in this region. It was most likely carried by Germanic warriors,

who broke it and sacrificed it to the gods. The sword was highly corroded.

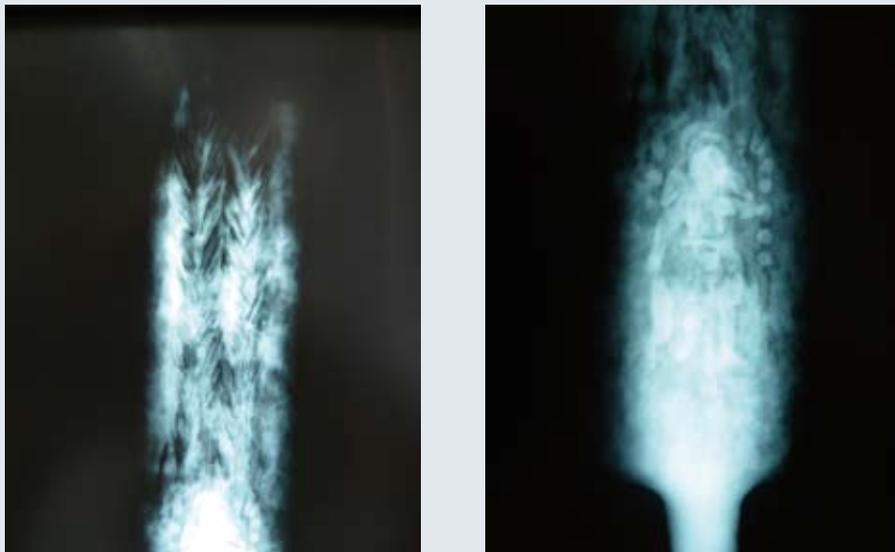
Fig. 2 The X-ray absorption images show the damascene structure of the steel and the inlaid work

The first examination step took place at the University of Applied Sciences HTW Berlin (Hochschule für Technik und Wirtschaft Berlin), where X-ray imaging analysis was performed on the sample. Figure 2 (left) shows a sandwich structure of carbon rich and carbon poor regions in the upper part of the sword. This is known as damascene steel, a steel type that combines hardness with elasticity.

The X-ray image of the area close to the handle shows two pieces of inlaid work, one on each side of the blade as it can be seen in figure 2 (right).

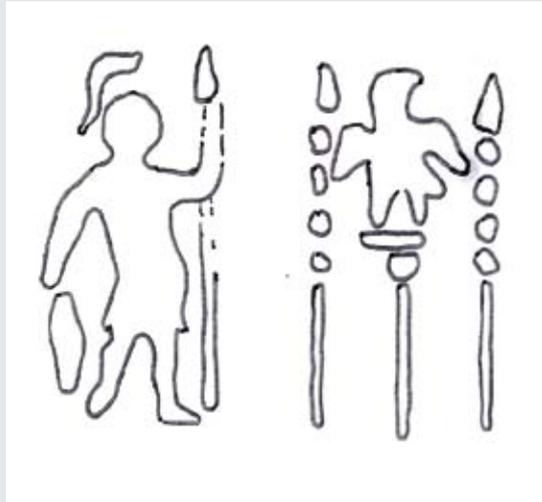
Fig. 3 Drawing of the inlaid work showing the goddess Victoria and the eagle

The inlaid work shows on one side Victoria, the flying goddess of victory and the tutelary goddess of the Roman emperor. On the other side of the blade is an eagle, the symbol of the Roman legion (see Fig. 3).

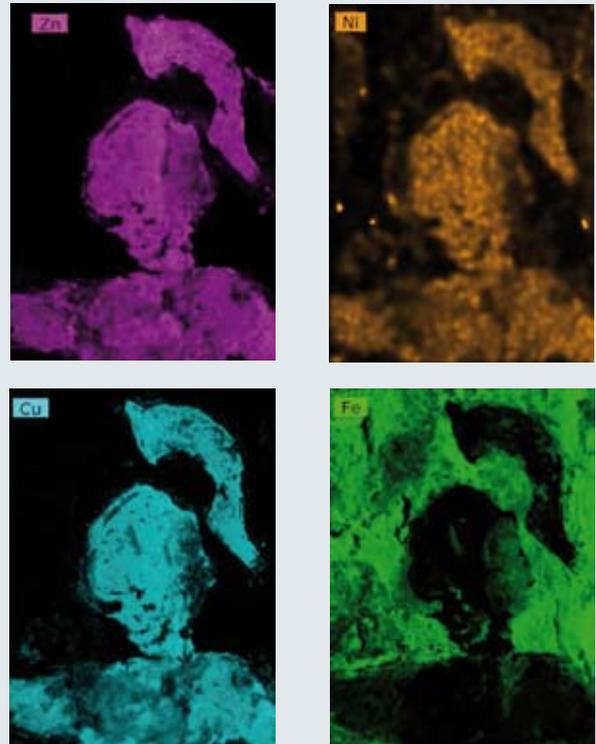
Fig. 4 Elemental distribution of the upper part of the inlaid work

The results of the distribution analysis are presented in figure 4. The small mapped area shows the shape of the head of Victoria. The inlaid work seems to be made of a Cu-Zn-alloy containing Ni; as expected, the blade is made of steel.

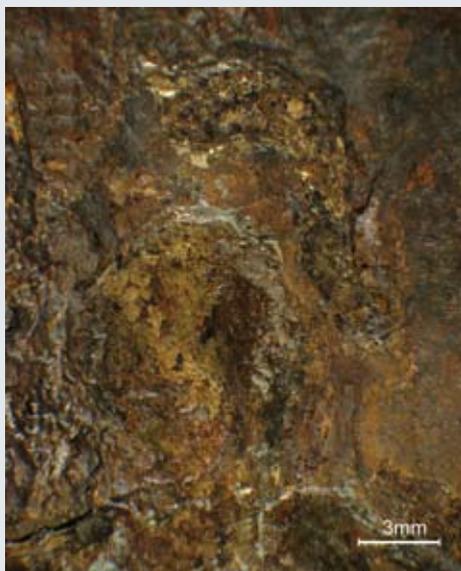
Fig. 5 Picture showing the inlaid work on the blade of the sword

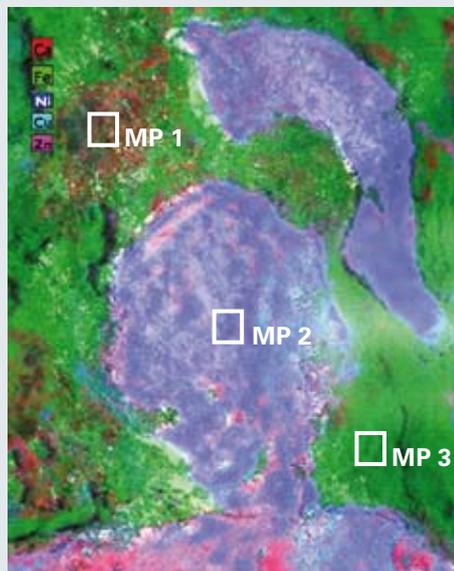
Fig. 6 Multi-element image showing the distribution of Ca, Fe, Ni, Cu and Zn in the upper area of the head of Victoria with the measurement points (MP) 1, 2 and 3 indicating the measurement locations.

Single spectra were accumulated of different locations on the inlaid work (see figure 6). The HyperMap function permits to summarize the spectra of several pixels with the same composition. The measured locations are highlighted on the mixed image of all detected elements.

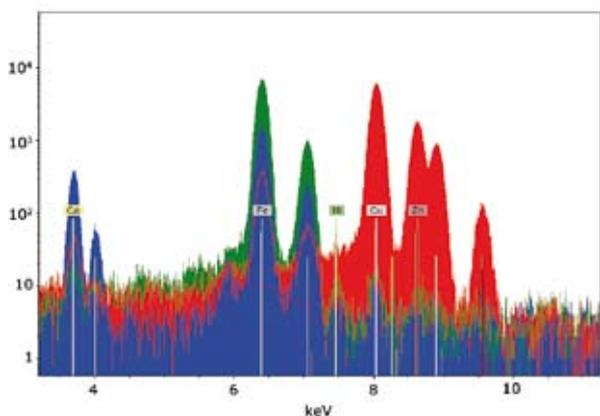
Fig. 7 Spectra of the measurement points (MP1: blue, MP2: red, MP3: green)

- The inlaid work (measurement point 2) is made of brass (Cu and Zn). The single element distribution suggested that the inlaid work contains Ni. However, the red spectrum of figure 7 shows that there is no Ni, but the spectral background is high due to the shelf of the high Cu and Zn peaks. This has been considered for the quantification.

- The sword's blade is made of steel (measurement point 3, green spectrum). The steel contains Fe and traces of Mn and Ni. The other elements in this spectrum (Cu, Zn and Ca) result from contamination from the inlaid work and also from the environment, since the object lay on the ground for a long period of time.

- The results for the measurement point 1 (MP1) show a high content of Ca but reduced concentrations of Fe, Mn and Ni, as displayed in the blue spectrum of figure 7. The intensity of Cu and Zn is also higher than in MP3. This is probably due to a slightly different composition of the corrosion layer covering the metal.
